Flood Control Project Maintenance
2019 Structure Summary Report
Overall Unit and Item Ratings

Reclamation District No. 2063 Crows Landing

Lateral No. 6 Pumping Plant

Levee Inspection Report By Mile - Structure 2019

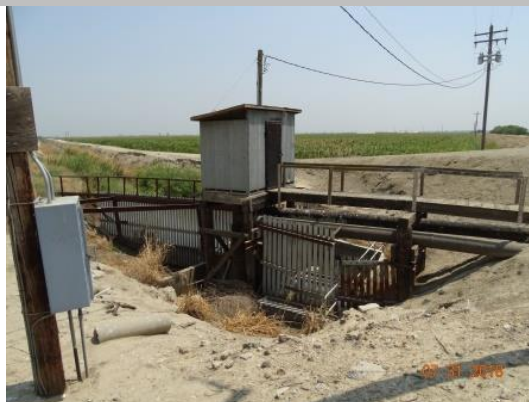
Photo 1 of 2 : ST_2019_RD2063_53_4_20190613_00003.jpg

LM Start	0.00	Rating **	A	Issue No.	4
LM End	0.00	Issue Type +	Ma	Location *	
Category	Pump Stations			GPS Latitude/Longitude	
				Start	End
Item	Plant Building			37.397931 °	37.397931 °
				-120.972176 °	-120.972176 °
DWR ID	DWR_RD2063_53_t_2012_4				
Action/Comments					
Inspector Comments: The plant building appeared to be in a good structural condition. Screens have been placed around the pumphouse to keep out nesting birds. Debris has been cleared, however bird feces should be cleaned from pumps and electrical components.

View of the pumping plant. (2018)

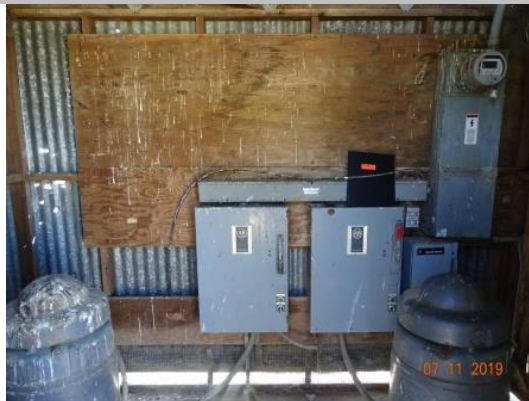
Photo 2 of 2 : ST_2019_RD2063_53_4_20190712_00020.jpg

LM Start	0.00	Rating **	A	Issue No.	4 (cont)	
LM End	0.00	Issue Type +	Ma	Location *		
Category	Pump Stations			GPS Latitude/Longitude		
				Start	End	
Item	Plant Building			37.397931 °	37.397931 °	
				-120.972176 °	-120.972176 °	
DWR ID	DWR_RD2063_53_t_2012_4					
Action/Comments						
Inspector Comments: The plant building appeared to be in a good structural condition. Screens have been placed around the pumphouse to keep out nesting birds. Debris has been cleared, however bird feces should be cleaned from pumps and electrical components.

View of pumphouse interior. (2019)

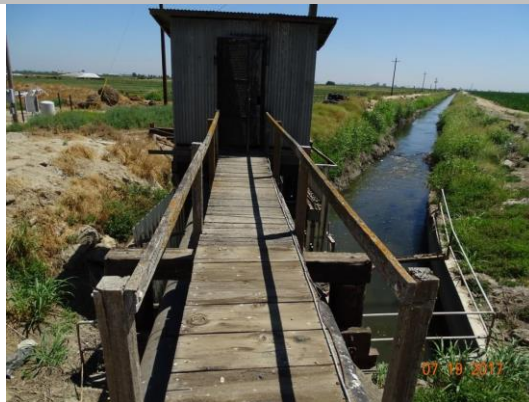
Photo 1 of 1 : ST_2019_RD2063_53_6_20190613_00007.jpg

LM Start	0.00	Rating **	M	Issue No.	6
LM End	0.00	Issue Type +	Ma	Location *	
Category	Pump Stations			GPS Latitude/Longitude	
				Start	End
Item	Safety			37.397931 °	37.397931 °
				-120.972176 °	-120.972176 °
DWR ID	DWR_RD2063_53_t_2012_6				
Action/Comments					
Inspector Comments: Right handrail leading up to pump house was unstable and may not prevent a fall if weight is applied to it.

View of the handrails.

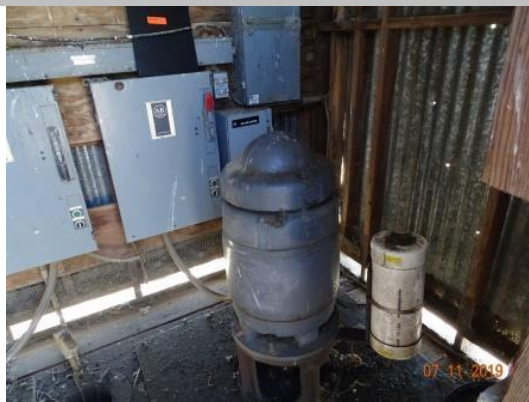
Photo 1 of 2 : ST_2019_RD2063_53_7_20190715_00022.jpg

LM Start	0.00	Rating **	A	Issue No.	7
LM End	0.00	Issue Type +	Ma	Location *	
Category	Pump Stations			GPS Latitude/Longitude	
				Start	End
Item	Pumps			37.397931 °	37.397931 °
				-120.972176 °	-120.972176 °
DWR ID	DWR_RD2063_53_t_2013_7				
Action/Comments					
Inspector Comments: Pumps appeared to function, but should be cleaned of bird feces.

View of one of the pumps inside the plant. (2019)

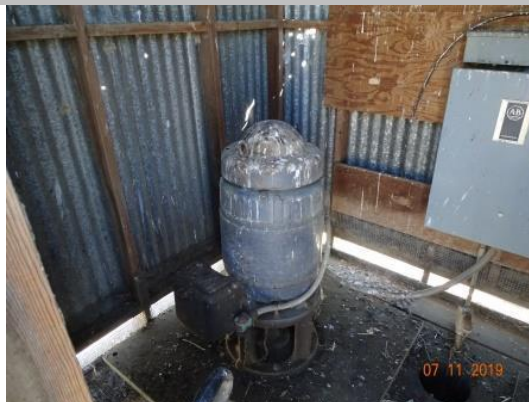
Photo 2 of 2 : ST_2019_RD2063_53_7_20190715_00021.jpg

View of the second pump inside the plant. (2019)

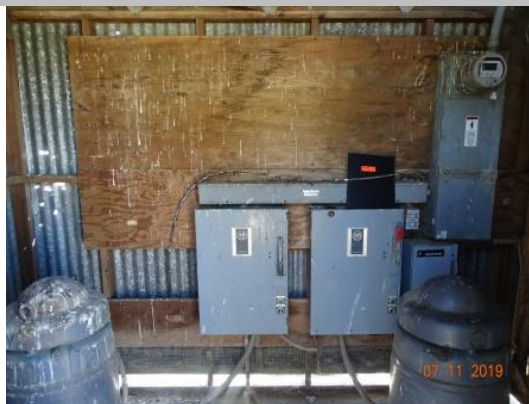
Photo 1 of 1 : ST_2019_RD2063_53_10_20190715_00024.jpg

LM Start	0.00	Rating **	M	Issue No.	10
LM End	0.00	Issue Type +	Ma	Location *	
Category	Pump Stations			GPS Latitude/Longitude	
				Start	End
Item	Pump Control Systems			37.397931 °	37.397931 °
				-120.972176 °	-120.972176 °
DWR ID	DWR_RD2063_53_t_2012_10				
Action/Comments					
Inspector Comments: Pump control systems were operational, but feces should be removed.

View of power meter and pump control system. (2019)

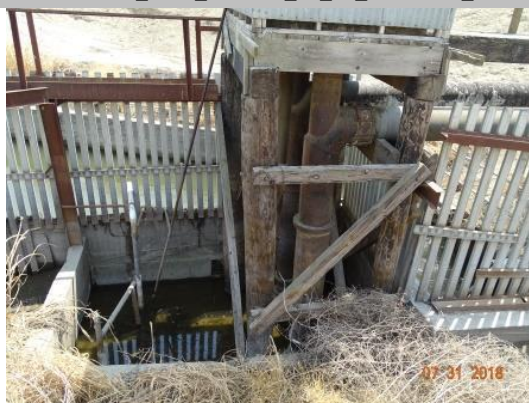
Photo 2 of 2 : ST_2019_RD2063_53_12_20190613_00013.jpg

LM Start	0.00	Rating **	A	Issue No.	12
LM End	0.00	Issue Type +	Ma	Location *	
Category	Pump Stations			GPS Latitude/Longitude	
				Start	End
Item	Sumps/Wet Well			37.397931 °	37.397931 °
				-120.972176 °	-120.972176 °
DWR ID	DWR_RD2063_53_t_2012_12				
Action/Comments					
Inspector Comments: The sump well was free of debris.

View of sump well. (2018)

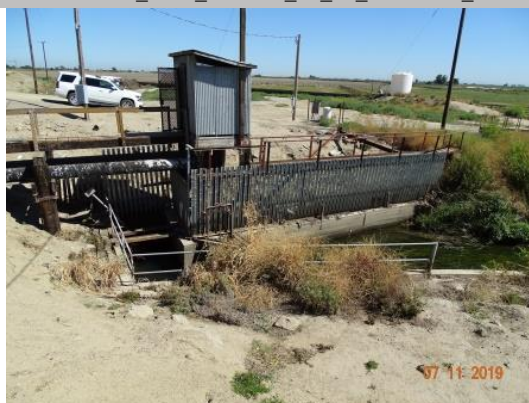
Photo 1 of 1 : ST_2019_RD2063_53_13_20190716_00029.jpg

LM Start	0.00	Rating **	A	Issue No.	13
LM End	0.00	Issue Type +	Ma	Location *	
Category	Pump Stations			GPS Latitude/Longitude	
				Start	End
Item	Trash Racks			37.397931 °	37.397931 °
				-120.972176 °	-120.972176 °
DWR ID	DWR_RD2063_53_t_2012_13				
Action/Comments					
Inspector Comments: The trash racks appears to be in good working condition.

View of trash racks. (2019)

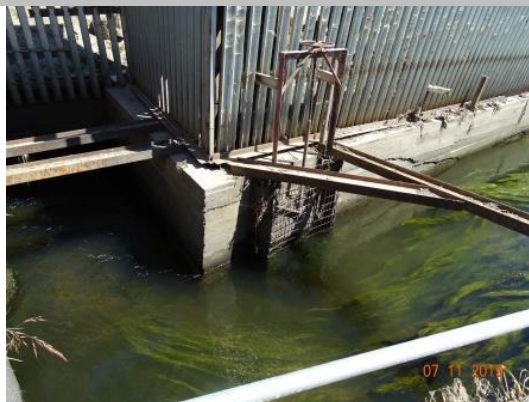
Photo 1 of 1 : ST_2019_RD2063_53_11_20190715_00025.jpg

LM Start	0.00	Rating **	A	Issue No.	11
LM End	0.00	Issue Type +	Ma	Location *	
Category	Pump Stations			GPS Latitude/Longitude	
				Start	End
Item	Sluice / Slide Gates			37.397931 °	37.397931 °
				-120.972176 °	-120.972176 °
DWR ID	DWR_RD2063_53_t_2012_11				
Action/Comments					
Inspector Comments: The slide gate appeared to be in working condition.

View of slide gate to sump well. (2019)

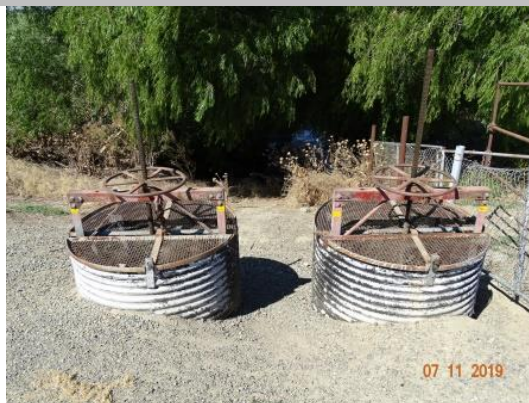
Photo 1 of 1 : ST_2019_RD2063_53_17_20190716_00032.jpg

LM Start	0.00	Rating **	A	Issue No.	17
LM End	0.00	Issue Type +	Ma	Location *	
Category	Pump Stations			GPS Latitude/Longitude	
				Start	End
Item	Manual Gate Operators			37.397931 °	37.397931 °
				-120.972176 °	-120.972176 °
DWR ID	DWR_RD2063_53_t_2012_17				
Action/Comments					
Inspector Comments: The manual gate operators were lubricated and in good working condition.

View of manual gate operators. (2019)

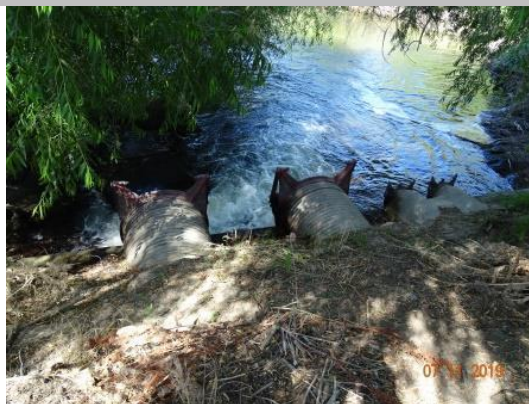
Photo 1 of 2 : ST_2019_RD2063_53_16_20190716_00030.jpg

LM Start	0.00	Rating **	A	Issue No.	16
LM End	0.00	Issue Type +	Ma	Location *	
Category	Pump Stations			GPS Latitude/Longitude	
				Start	End
Item	Flap Gates			37.397931 °	37.397931 °
				-120.972176 °	-120.972176 °
DWR ID	DWR_RD2063_53_t_2013_16				
Action/Comments					
Inspector Comments: Flap gates appeared to be in a good working condition.

View of the flap gates. (2019)

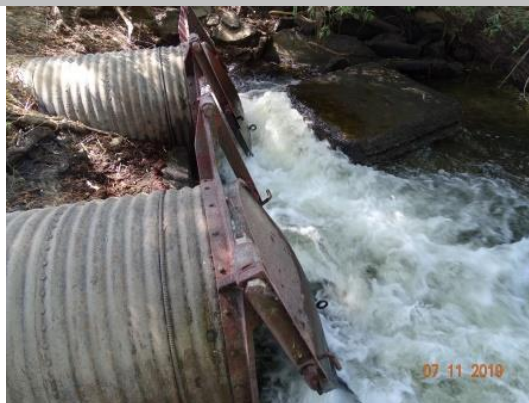
Photo 2 of 2 : ST_2019_RD2063_53_16_20190716_00031.jpg

LM Start	0.00	Rating **	A	Issue No.	16 (cont)	
LM End	0.00	Issue Type +	Ma	Location *		
Category	Pump Stations			GPS Latitude/Longitude		
				Start	End	
Item	Flap Gates			37.397931 °	37.397931 °	
				-120.972176 °	-120.972176 °	
DWR ID	DWR_RD2063_53_t_2013_16					
Action/Comments						
Inspector Comments: Flap gates appeared to be in a good working condition.

View of the flap gates. (2019)

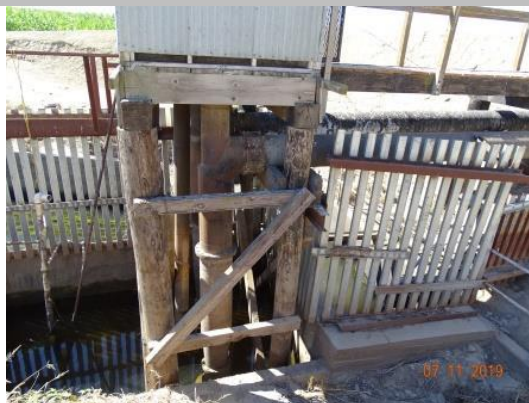
Photo 1 of 2 : ST_2019_RD2063_53_20_20190716_00033.jpg

LM Start	0.00	Rating **	A	Issue No.	20
LM End	0.00	Issue Type +	Ma	Location *	
Category	Pump Stations			GPS Latitude/Longitude	
				Start	End
Item	Intake and Discharge Pipes			37.397931 °	37.397931 °
				-120.972176 °	-120.972176 °
DWR ID	DWR_RD2063_53_t_2013_20				
Action/Comments					
Inspector Comments: The intake and discharge pipes appeared to be in good condition.

View of intake pipes. (2019)

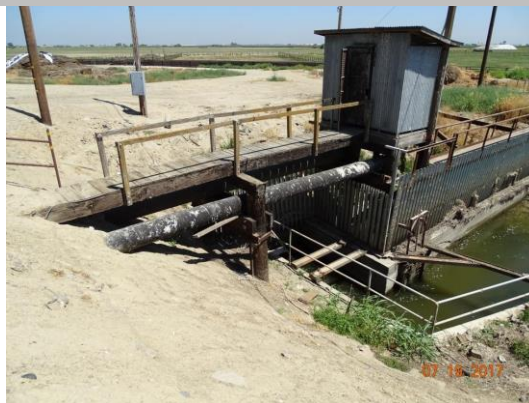
Photo 2 of 2 : ST_2019_RD2063_53_20_20190613_00018.jpg

View of the intake pipes. (2017)
